**SAMPLE BUYERS REPORT**

Re: Property address

Client  
Comprehensive Evaluation Report  
Property Address

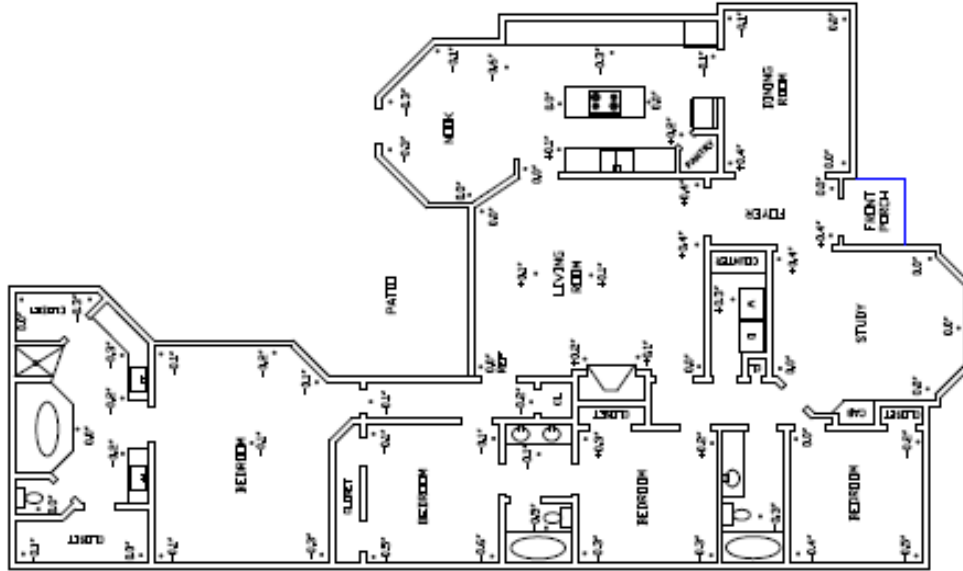
**ELEVATION SURVEY**

Relative floor elevations were measured using a Stanley "Compulevel"®, an electronic measuring device that functions in a manner similar to a "water level", but with a digital display. This survey found that elevations, measured in the house and adjusted for changes in floor coverings, ranged from a high of +0.6" to a low of -0.6". In the garage, elevations were not adjusted for the step-down into the garage and ranged from -2.8" to -5.4", indicating the floor slope typically built-in to facilitate drainage out of the garage when water drips off of a car. A drawing showing the results of this survey is attached for reference.
